UNDERWATER BRIDGE INSPECTION REPORT

STRUCTURE NO. L4675

WEISEL CREEK

DISTRICT 6 - FILLMORE COUNTY

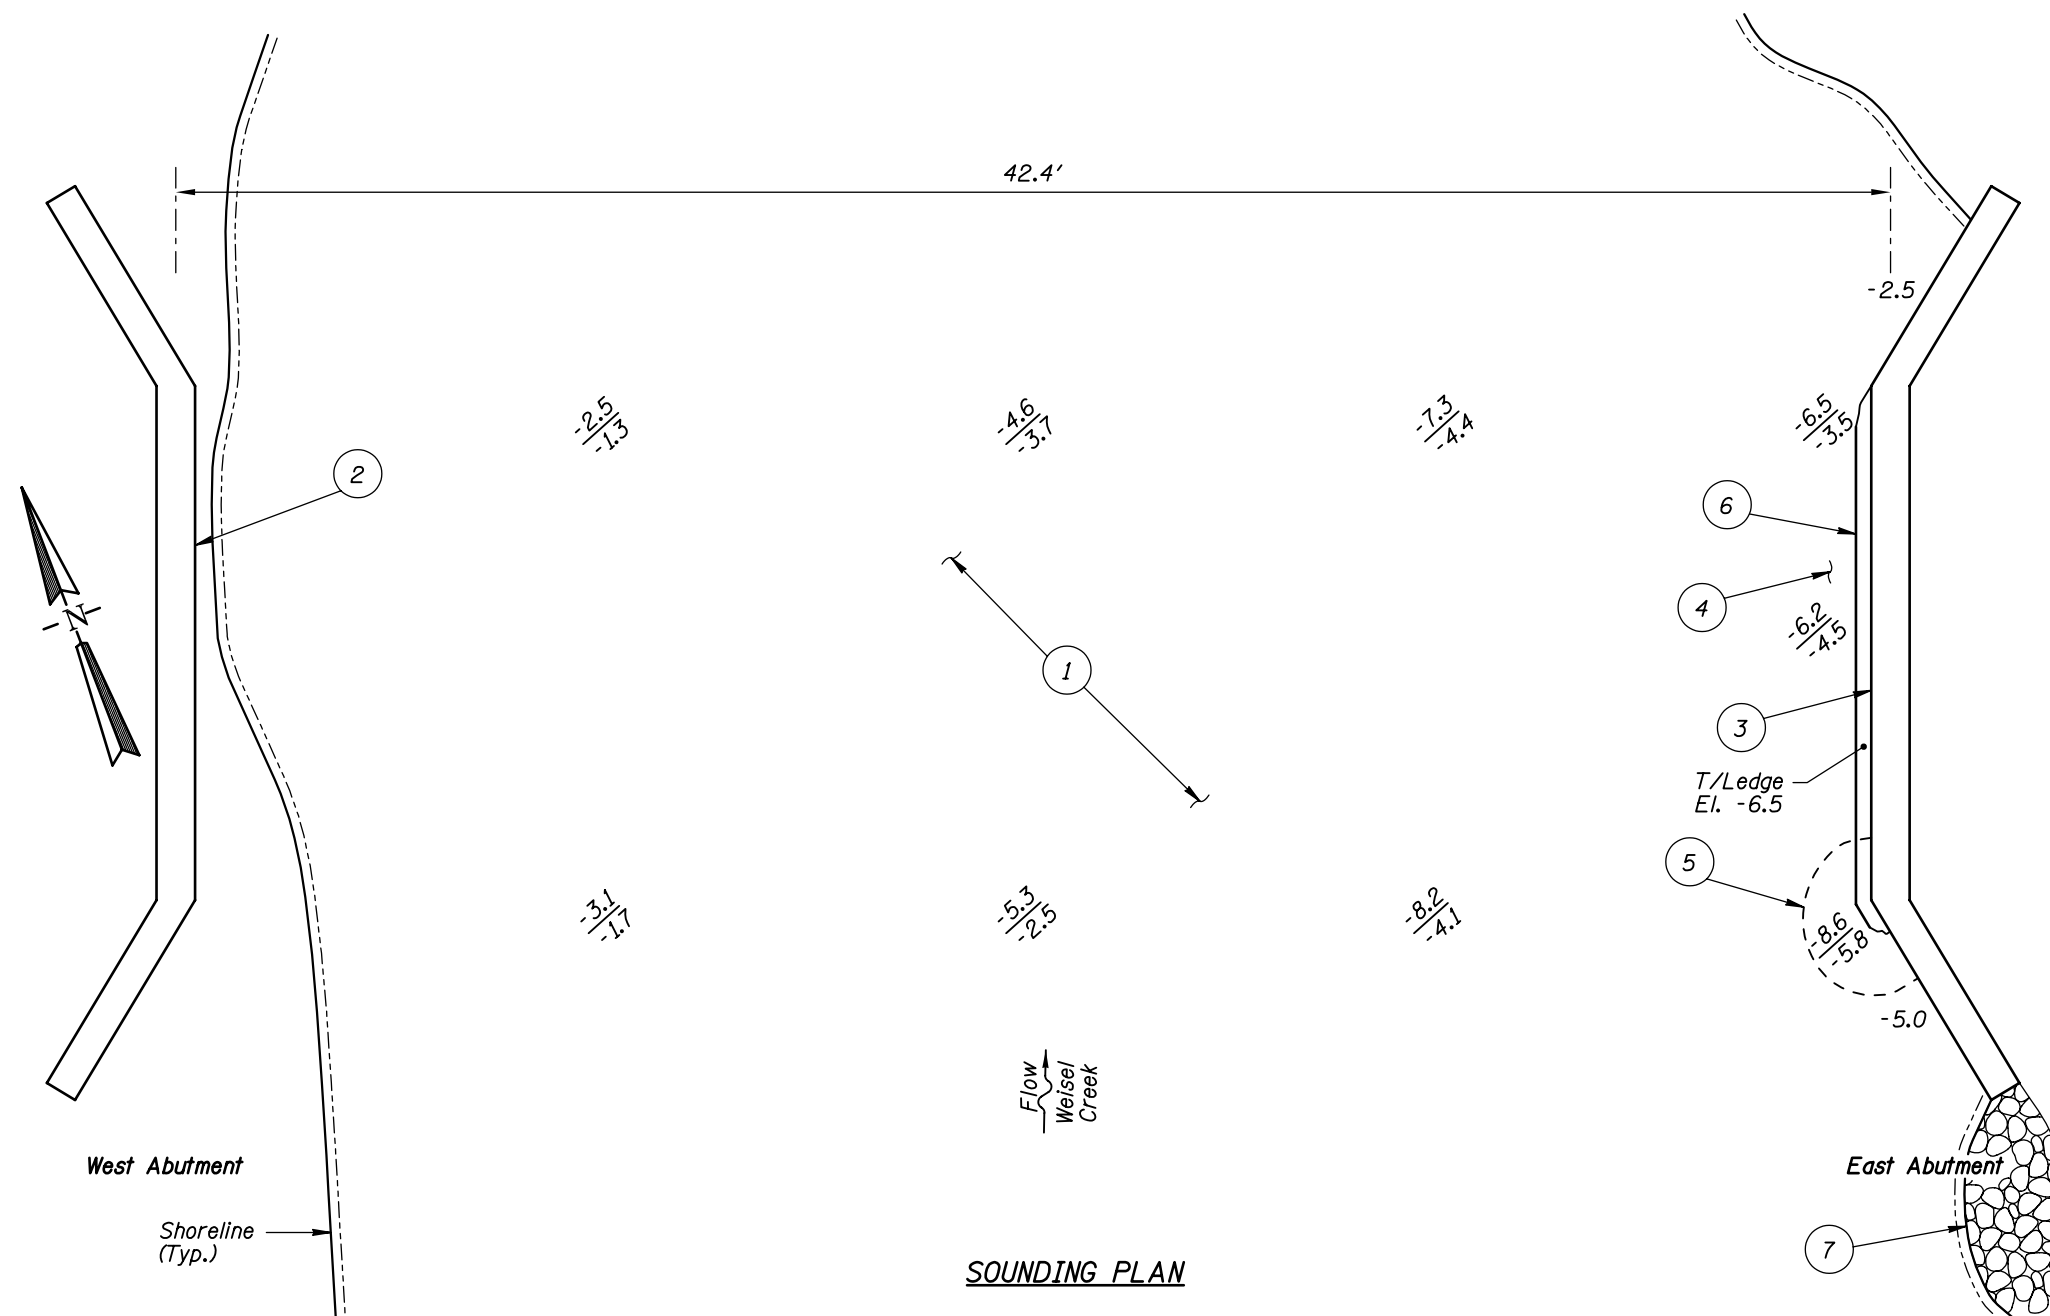
INSPECTION AND SOUNDING PLAN

- 1 The channel bottom material consisted of a soft silt material with 1 foot of maximum probe rod penetration.
- 2 The mortar in the joints was deteriorated along the wall from 6 inches above to the groundline with 3 inch typical penetrations, and 8 inch maximum penetrations near the groundline.

- 3 The mortar in the joints was deteriorated along the abutment wall from 6 inches above the waterline to 1 foot below the waterline with 4 inch typical penetrations, and 12 inch maximum penetrations near the waterline.

- 4 Riprap was observed along the entire face of the abutment, extending 3 feet into the channel.
- 5 A minor scour depression was observed, 2.5 feet deep with a radius of 5 feet. Riprap lined the bottom of the depression.

- 6 A 1.5-foot-wide ledge was exposed along the breastwall with up to 2 feet of vertical exposure and with no undermining detected.
- 7 The embankment protection was undermined 4 feet below the waterline.

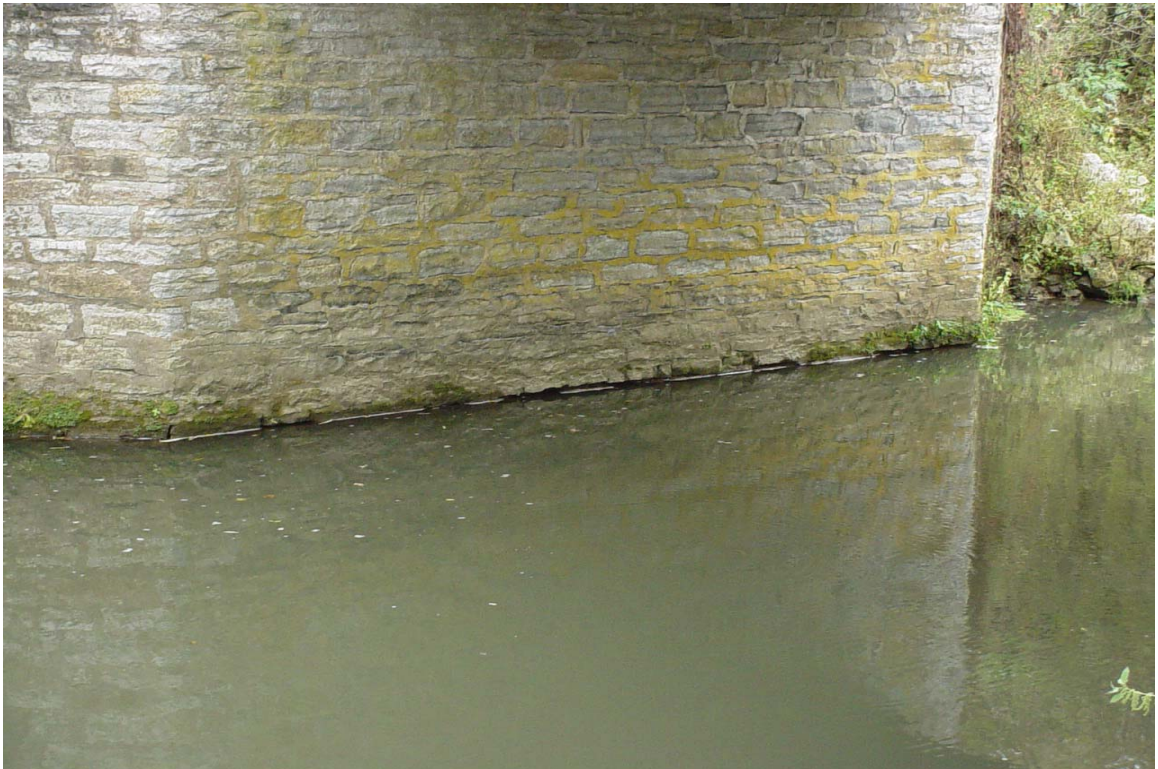
- (A) The abutment was in satisfactory condition with moderate deterioration of the masonry and a loss of mortar at the joints from 6 inches above to 1 foot below the waterline with typical penetrations of 4 inches and a maximum penetration of 12 inches.
- (B) A minor scour depression, 2.5 feet deep with a radius of 5 feet, was observed at the upstream corner of the East Abutment. The bottom of the depression was lined with riprap.
- (C) A 1.5-foot-wide ledge was exposed along the entire breastwall with up to 2 feet of vertical face exposure and with no undermining detected.

Photograph 2. View of East Abutment, Looking South.

- (A) The masonry joints of both abutments should be repointed during routine maintenance of the bridge.
- (B) Since insufficient bridge foundation information was available, monitor the East Abutment for any undermining during future inspections.
- (C) Reinspect the submerged substructure units at the normal maximum recommended (NBIS) interval of five (5) years.

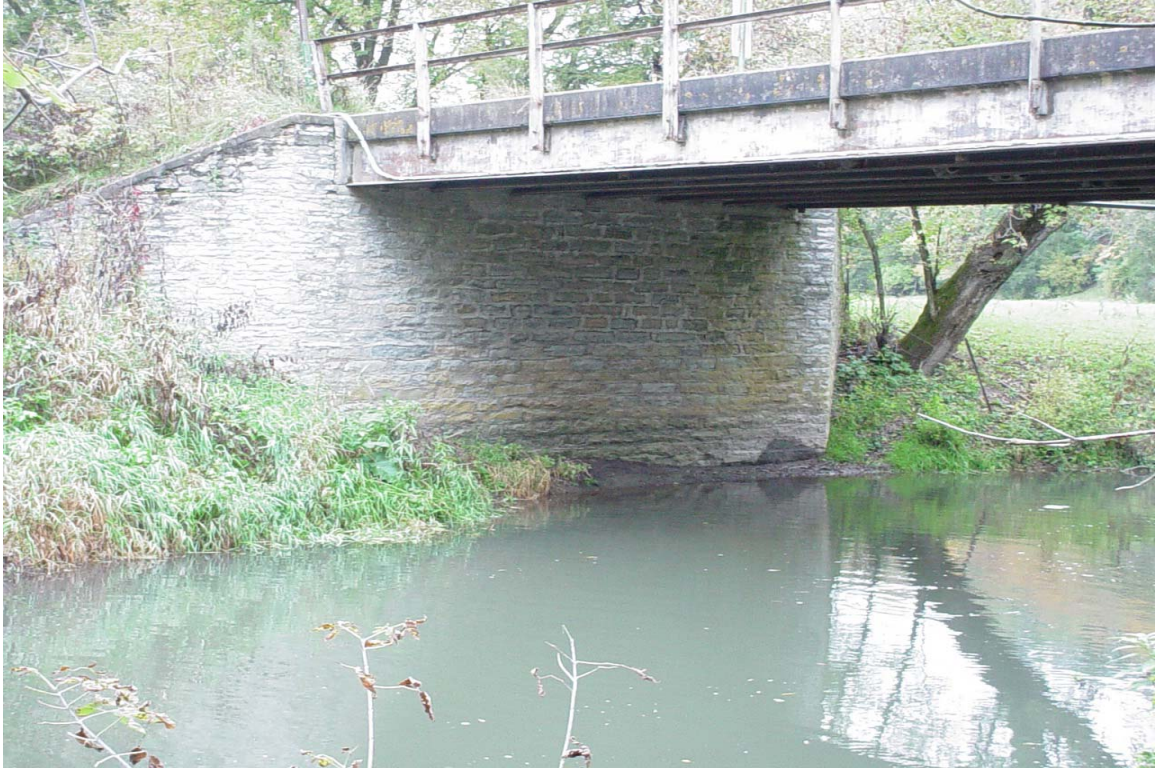
Photograph 3. View of West Abutment, Looking North.
